Llwynypia 32" Cast Iron Trunk Sewer Repair

Site Location:	>> Llwynypia, Tonypanyd
Client:	>> Dwr Cymru Welsh Water
Contract Value:	>> £535,000
Project Duration:	>> 18 Weeks

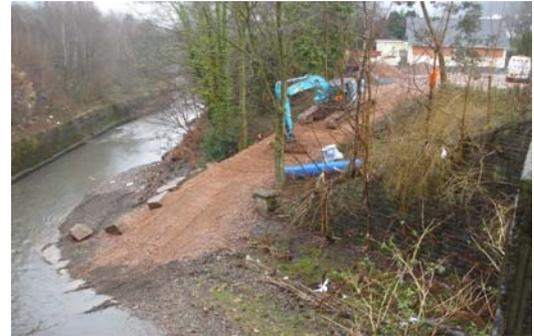
An existing concrete boundary/retaining wall positioned along the edge of the river had partly collapsed and was leaning on-top of the foul sewer. The weight of the concrete wall was pushing the cast iron sewer pipe off its support plinths causing the pipeline fail and leak raw sewerage into the river. The main scope of work was to prevent the foul sewerage spill into the river. The sewer pipeline was positioned in the bed of the river tight against the edge of the river. Access to the working area was a huge challenge. The damaged section of sewer was located at the rear of houses and the line of the river on this section was edged by a concrete wall on both banks. The only practical access point into the river bed was via the garden of a property downstream of the working area. The Land Agents for DCWW arranged for emergency access into the garden to enable construction of a stone access ramp from the garden to the river bed. The ramp was steep and required thousands of tonnes of imported crusher run stone to construct. Tree clearance was required to be undertaken within the area of the ramp.

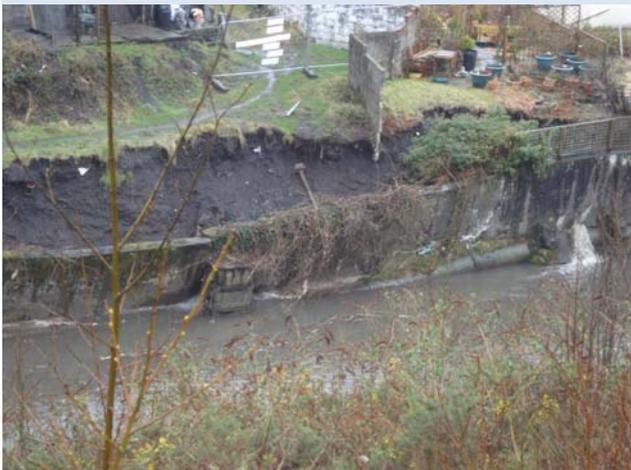
Having completed construction of the raised access roadway within the river bed the full effect of the damaged sewer could only then be assessed by DCWW and their designers. It was obvious that the collapsed concrete wall was the problem. The sewer pipeline was sagging under the weight and the pipeline had fractured in several locations. There was foul spillage into the river, especially during times of high flows within the sewer. The sewer appeared as if it could catastrophically fail at any time. Following inspection it was decided that the concrete wall that had collapsed onto the sewer had to be fully removed and the full section of trunk sewer had to be removed and replaced with new pipe. To try and prevent any further movement of the damaged sewer during the wall removal we used the block stone to temporarily support the front edge of the pipeline.

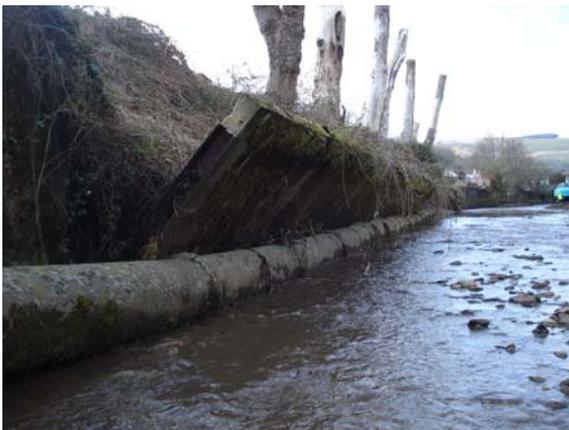
Prior to beginning the removal of the concrete wall it was necessary to fell 6No. large dead trees that were running along the top of the river bank behind the concrete wall. It is these trees that possibly caused the eventual collapse of the concrete wall. A large telescopic tracked crane was utilised to lower the cut sections of tree trunk to the ground level before further cutting into smaller manageable sections.

Following removal of the trees the concrete wall was demolished using a machine mounted impact hammer and mechanical grab. This operation was carried out very carefully so as not to cause any further damage to the sewer pipeline.

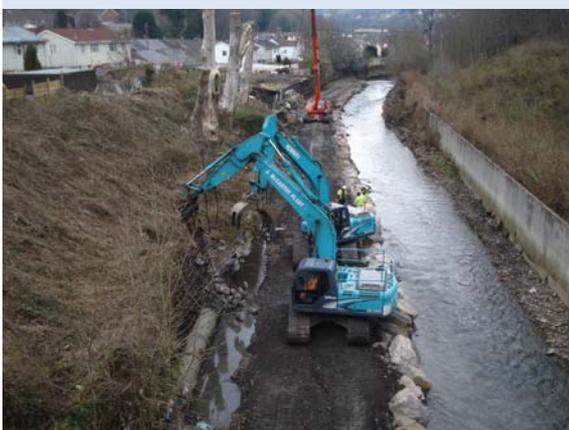
A section of the concrete wall upstream of the sewer replacement was leaning at a precarious angle and appeared if it could also collapse in the near future. This was discussed with DCWW and a decision was made to leave this section of wall, but to protect it by placing the block-stone used for the

During replacement of the foul pipeline further site meetings were undertaken to discuss the permanent protection to the river bank at the rear of the replaced pipeline where the concrete wall once stood. Following numerous discussions it was decided that the river bank would be protected with large block stone. The designers visited site and a design was issued. The replacement of the concrete wall was considered, but, due to the available space, time and difficulty/cost in construction it was decided to use the block-stone. The risk was that if the river went into flood conditions following replacement of the foul sewer, the flood water could wash away the unprotected river bank, so for this reason it was decided to go with the block-stone protection.

temporary raised access road along its base. This would prevent the wall from collapse and prevent any further undermining of the wall from river flows. On completion of the construction works the temporary raised access roadway was removed with all the river cobble material being put back across the bed of the river. In-fact, the river bed was hugely improved by this operation with the water flow being aligned centrally to the river bed.
