TREFOREST 19" BURST

Emergency repair to existing 19" Cast Iron water main

Site Location:	>> Treforest 19" Burst
Client:	>> Welsh Water

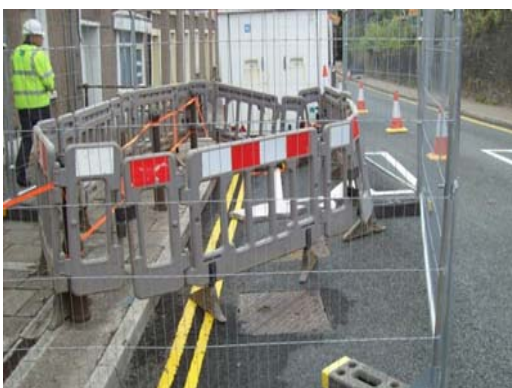
Although it's classed as a burst and in this case a lead joint had blown out of the existing coupling, water is still flowing through the pipe and reaching the consumer. It was decided by DCWW to carry out the repair by installing flow stops and an overland rider. The benefit of this method is the water is not turned off and as a result no customers are effected.

Location of burst main at Park Street

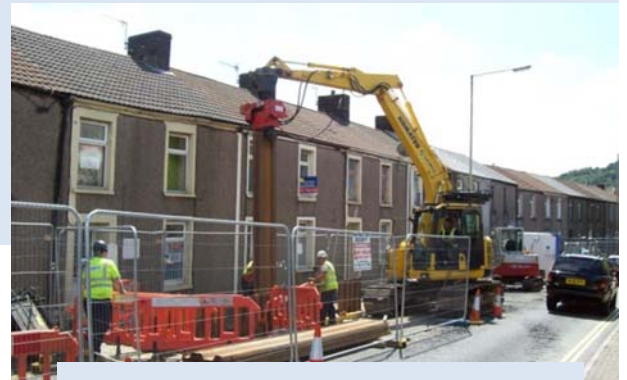
Sheet piling to South connection point.

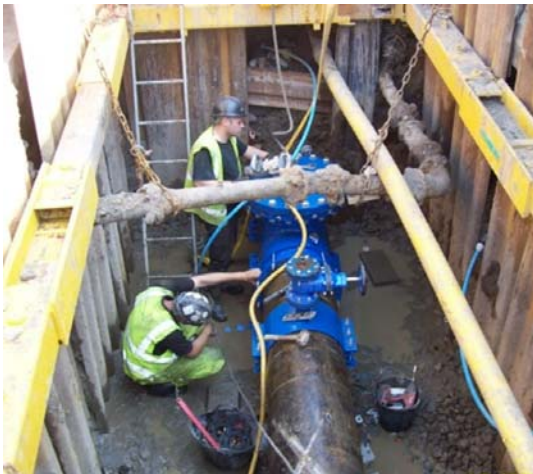
Temporary works installed at the North Connection. High pressure gas and water main present within the excavation. Single flow stop and equalisation tee fully installed.

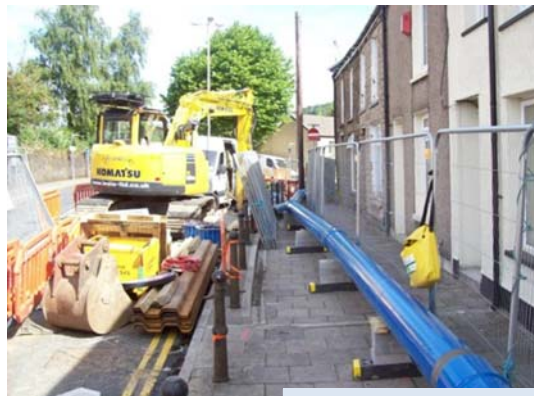
Temporary welded steel overland rider

- Install a welded steel overland rider that was coupled up to the flow stop rigs each side of the leak.
- Chlorination of overland rider
- Simultaneously insert the flow stops each side of the leak, so water is isolated through the existing water main. Water flows were then turned so it flowed through the temporary overland rider.
