Llwynypia 32" Cast Iron Trunk Sewer Repair

Site Location:	>> Llwynypia, Tonypanyd
Client:	>> Dwr Cymru Welsh Water
Contract Value:	>> £535,000
Project Duration:	>> 18 Weeks

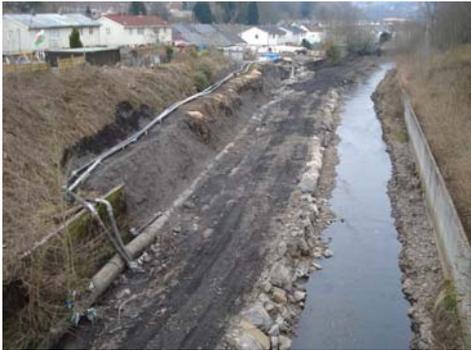
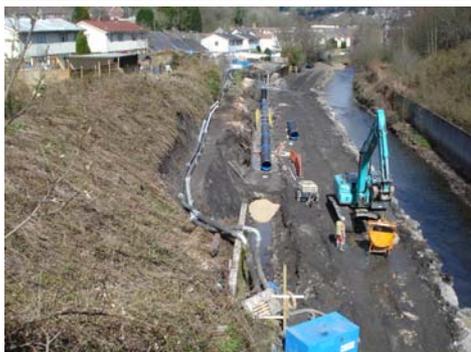
On completion of the construction works the temporary raised access roadway was removed with all the river cobble material being put back across the bed of the river. In-fact, the river bed was hugely improved by this operation with the water flow being aligned centrally to the river bed.

The excavators worked their way out of the river bed and finally removed the stone access ramp formed into the river. Reinstatement of the garden then followed.
