TREFOREST 19" BURST

Emergency repair to existing 19" Cast Iron water main

Site Location:	>> Treforest 19" Burst
Client:	>> Welsh Water

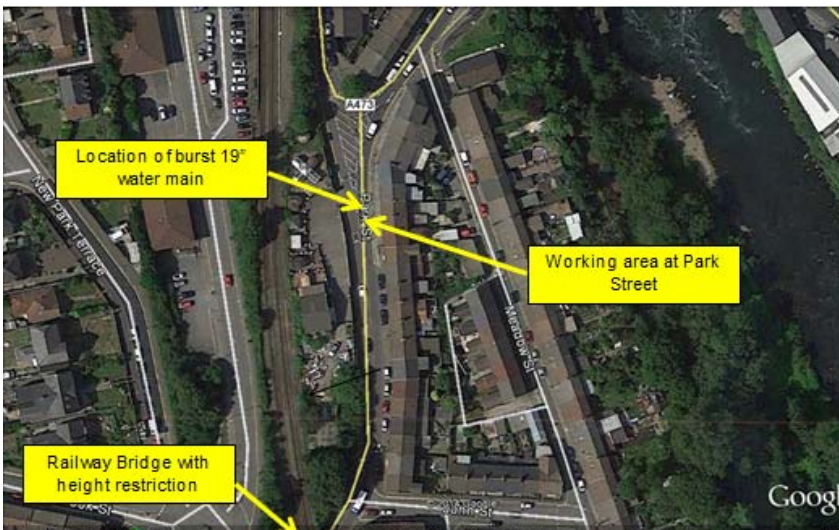
Aerial view of the site showing site restrictions, i.e., low bridge approaching construction area, terrace houses within 2m of burst water main, one way system approaching University of Glamorgan.
