BIRCHGROVE

| Site Location: | Birchgrove Service Reservoir |
| Client: | Dwr Cymru Welsh Water |

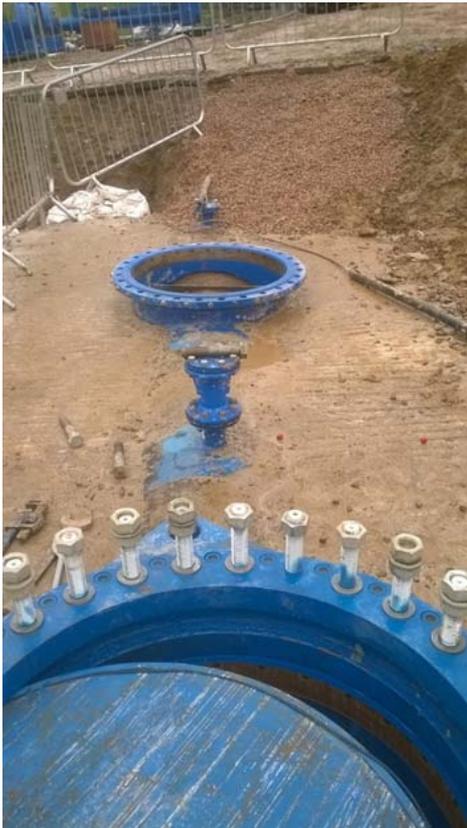
The reservoir was in need of cleaning so DCWW could meet their water quality obligations. In order to achieve this, the 48" inlet and the 48" outlet mains required isolating so the reservoir could be drained down. The existing butterfly valves on both mains located within a 7.5m deep valve chamber in the valve house had not been operated for some time and required changing to ensure a safe isolation could be achieved for the reservoir cleaning team.

Lewis CE were contracted by Dwr Cymru Welsh Water to replace the 4 butterfly valves within the valve house. This required the excavation of both the inlet and outlet mains and the temporary isolation the flows from both the inlet and outlet mains below the reservoir in a near by field. This would be achieved by installing double flowstops on both mains at the same time.

The twin 48" mains were excavated around whilst still live. Four flowstop tee's were the welded onto the main and surrounded in concrete. This would allow 48" valves to be installed and the mains to be drilled ready the house the flow stop plugs. The four 5.5m long flowstops were the installed on to the valves.

These flow stops were inserted into both 48" mains to isolate the flow and allow works to commence on the vales replacement.

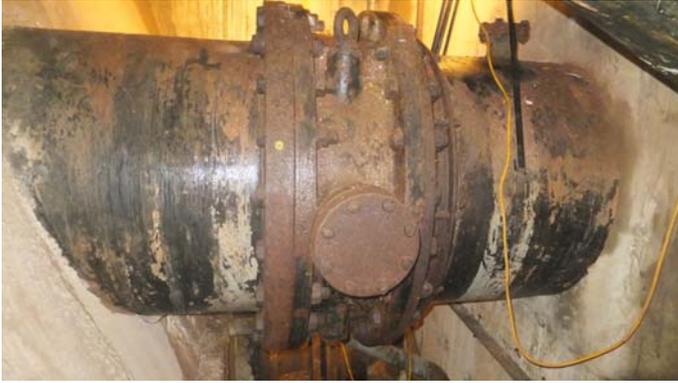
The four butterfly valves within the valve chamber were in poor condition and the bolts holding them in place had rusted over time. Each of these valves had to be replaced within the existing valve chamber that was 7.5m in depth with very restricted working room.

The valves were removed one at a time and lifted from the chamber via an overhead gantry.

The new valve was then lowered into place and fitted.

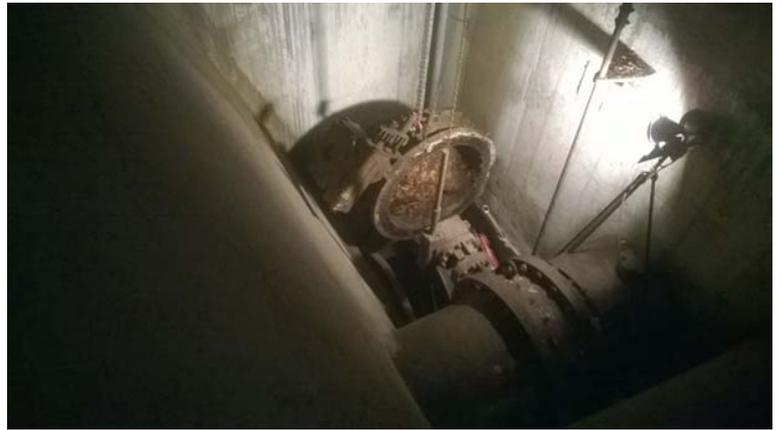
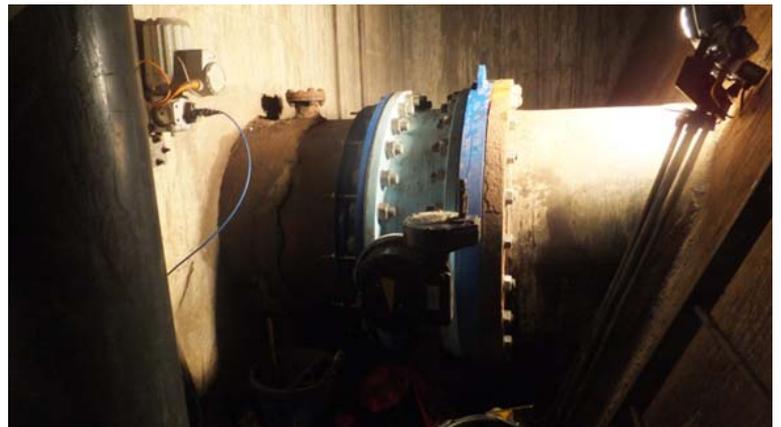
The four new Butterfly valves were installed successfully despite the old valves proving extremely difficult to remove due to their condition and the restricted working room and the reservoir handed over to the cleaning team on programme.
