Muddy waters doesn't stop a first class job

The Central Distribution and Capital Delivery team in the south east recently had to work in very difficult conditions to repair an emergency burst near Ynysmaerdy, Llantrisant.

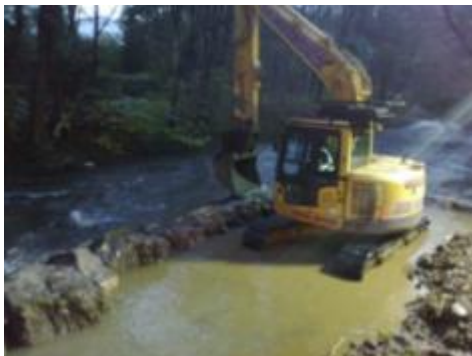
The burst was right on the edge of the river bank, down a narrow path which was originally covered by trees. **Lewis Civil Engineering**, the contractors on the job, had to clear a lot of the wooded area before they could actually get machinery in to the location of the pipe. Then they had to construct a small river wall in the water to divert the flow of the river away from the pipe in order to access the burst.

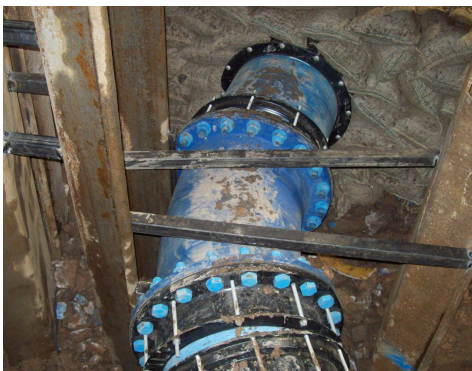
Furthermore, due to the abnormal size of the main, a specialist fabricating contractor from the north east of England was contacted to fabricate repair fittings which were transported to site within 24 hours. It took approximately ten days for the team on site to carry out the work, which involved very long days and working through the night to minimise disruption to residents. A great example of great team working and perseverance to get the job done.
